[Docket No. FAA-2016-9418; Product Identifier 2016-NE-23-AD; Amendment 39-19167; AD 2018-02-14]

Airworthiness Directives; Honeywell International Inc. Turboprop and Turboshaft Engines

ACTION: Final rule.

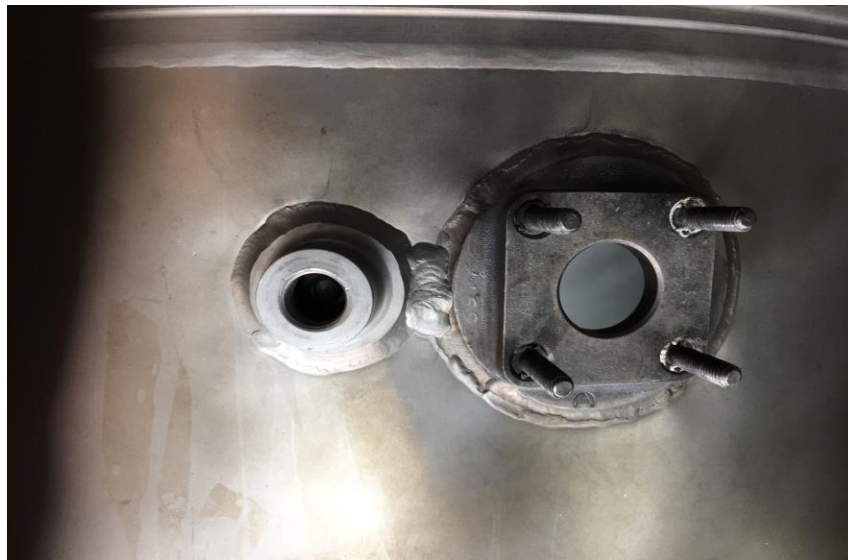
Figure 1 to Paragraph (h) of this AD. Combustion Chamber Case Assembly Without the One-Piece Bleed Pad with P3 Boss

(2) For TPE331-3U, -3UW, -5, -5A, -5AB, -5B, -6, and -6A engines with combustion chamber case assemblies, P/Ns 869728-1, 869728-3, or 893973-5, installed, and without the one-piece bleed pad with P3 boss; and for TPE331-1, -2, and -2UA engines modified by National Flight Services, Inc., supplemental type certificate (STC) SE383CH, remove the combustion chamber case assembly from service at the next

removal of the combustion chamber case from the engine, not to exceed 3,700 hours time-in-service since last hot section inspection.

TPE331 model engines modified by STC SE383CH may be defined as the “Super 1” and “Super 2” for the compressor modification of the TPE331-1 and the TPE331-2, -2U, and -2UA engines, respectively. Figures 1 and 2 to paragraph (h) of this AD illustrate the appearance of combustion chamber case assembly, P/N 893973-5, without and with, respectively, the one-piece bleed pad with the P3 boss.

After the effective date of this AD, do not install a combustion chamber case assembly, P/N 869728-1, 869728-3, or 893973-5, in TPE331-3U, -3UW, -5, -5A, -5AB, -5B, -6, and -6A engines or in TPE331-1, -2, and -2UA engines modified by National Flight Services, Inc., STC SE383CH, unless the combustion chamber case assembly has a one-piece bleed pad with P3 boss.

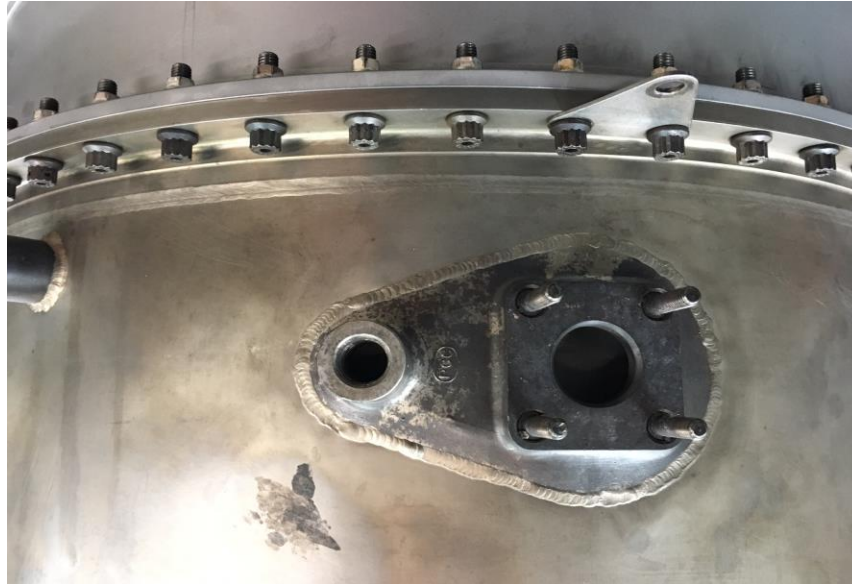
Figure 2 to Paragraph (h) of this AD. Combustion Chamber Case Assembly with One-Piece Bleed Pad with P3 Boss

We agree. We note that five of the six combustion chamber case assemblies that ruptured were assemblies without the one-piece bleed pad. P/N 3101668-x has the one-piece bleed pad with P3 boss, which demonstrated significantly reduced cracking between the P3 and bleed boss; therefore, this combustion chamber case assembly is not affected by this AD. No further changes are needed. We did not change this AD.
